Gourock Golf Club

Report on Proposed Course Improvement Works

11th April 2016

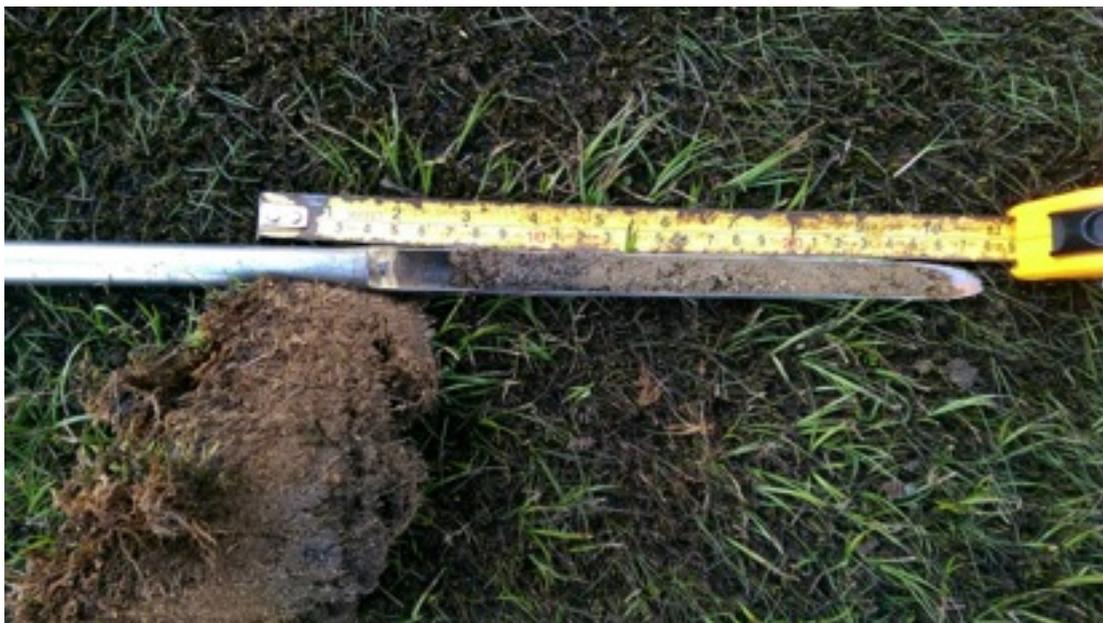
Fig. 1 Profile sample, 18th fairway.

The 18th fairway could be described as 'saturated and mobile underfoot in places' at inspection. As can be seen from the attached photograph, the upper 50-60mm (>2 inches) was dominated by a notably yellowed and saturated layer of variable organic matter. This overlay a dark, anaerobic (without air) layer which along with the organic matter smelled strongly of hydrogen sulphide (H₂S). This is an indicator of the activity of sulphate reducing bacteria

(undesirable and inefficient) and also of further acidification. Below this (>120mm) was a fairly uniform grey, fine textured, silty clay soil. This showed little aggregation or structure and was compacted in places and fairly dry, due to its generally impermeable nature and the water perched in the thatch above.
